MANUFACTURING METHODS FOR CUTTING, MACHINING AND DRILLING COMPOSITES

VOLUME II — TESTS AND RESULTS

GRUMMAN AEROSPACE CORPORATION
BETHPAGE, NEW YORK 11714

FINAL TECHNICAL REPORT AFML-TR-78-103, VOLUME II

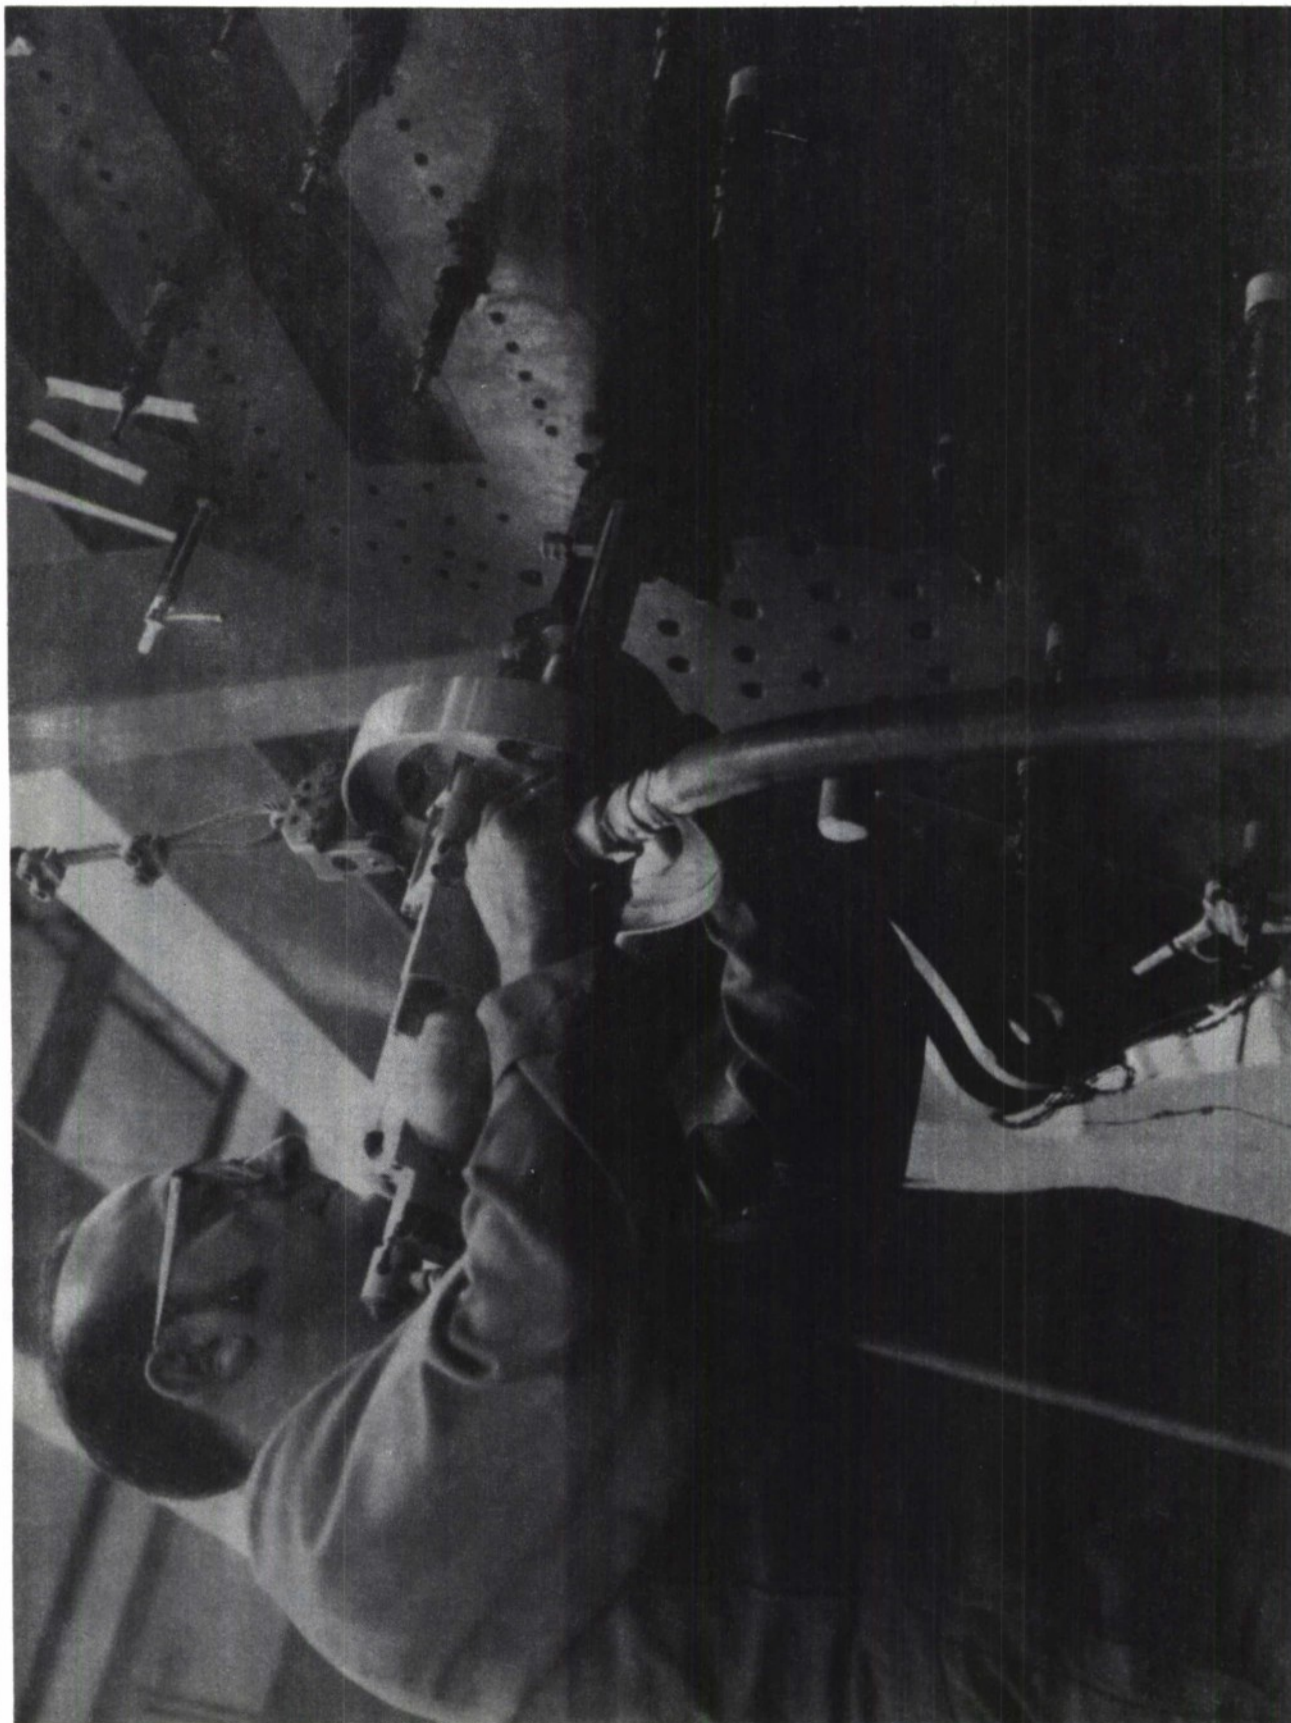
Figure 5-21 Winslow Spacematic Air-Powered Drill Unit (Model J-200)

Portable power equipment provides the rigidity and feed control (lacking in offhand equipment) that is necessary to extend tool life and to provide close-tolerance, high-quality holes. To take advantage of the higher speeds recommended for drilling graphite/epoxy, portable power equipment is also required. Rigid fixturing is necessary to maximize the benefits inherent in using portable equipment.

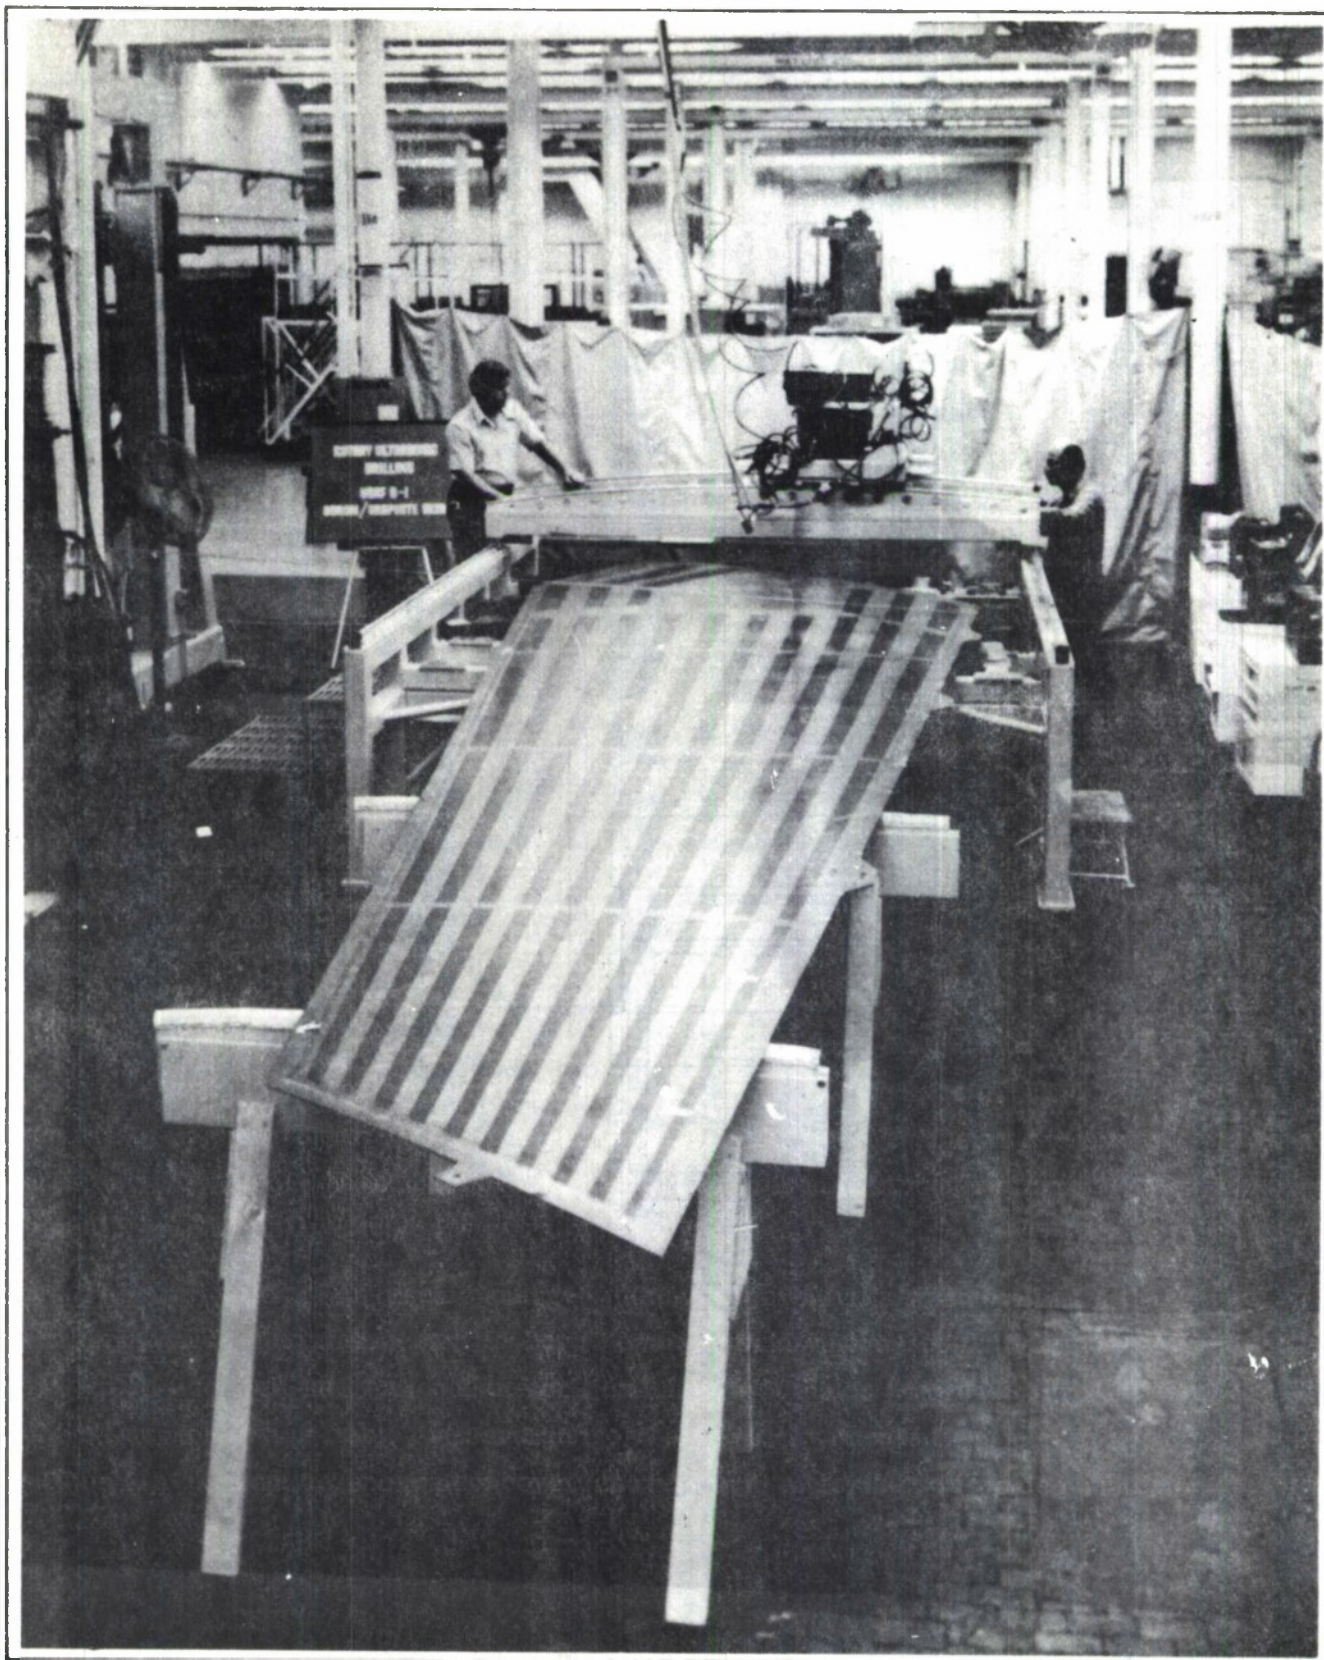
Figure 5-23 Ultrasonic Drilling Fixture for Hybrid Cover of B-1 Horizontal Stabilizer
